Number **1**  
 Date **APRIL 15, 1982**  
 Page **1** of **4**

Models Affected: **ADVANTAGE**      Class of Change: **MANDATORY**  
 Assembly(s) Affected: **ADV BASE ASSY**      Field Action: **INSTALL ON NEXT CALL**  
 Factory Implementation: **5-1-82**      Est. Install. Time: **0.5** Hrs.

# ADVANTAGE GROUNDING RETROFIT INSTRUCTIONS

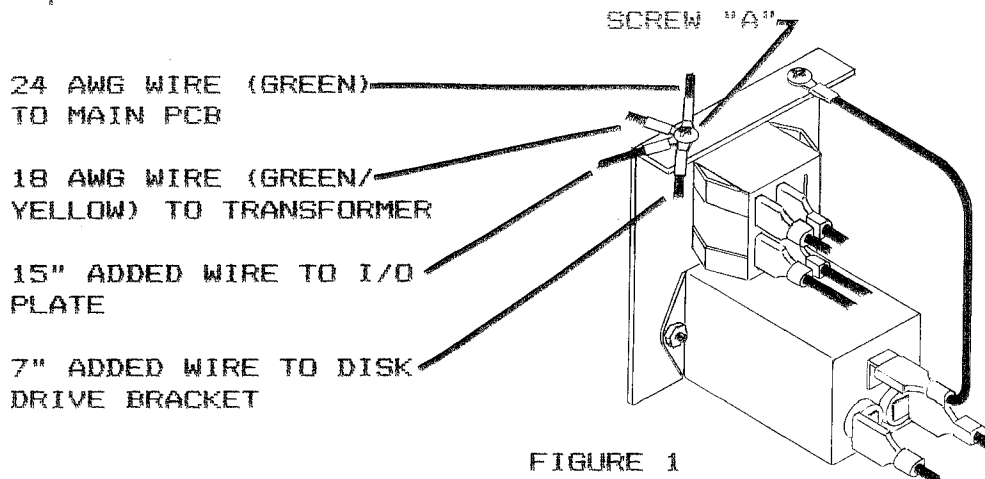
FIGURE 1

Provide adequate grounding between I/O plate, AC power panel and chassis of Advantage Computer. This change is mandatory to conform to UL & CSA standards. Without this modification, equipment could be damaged under certain short circuit conditions.

4. Attach one end of each of the two wires supplied in the kit to the screw removed in step 3 along with the two wires already attached to the screw and replace the screw on the AC power panel.
5. Using Figure 2 as a reference, remove screw A on the I/O mounting panel. Discard this screw.

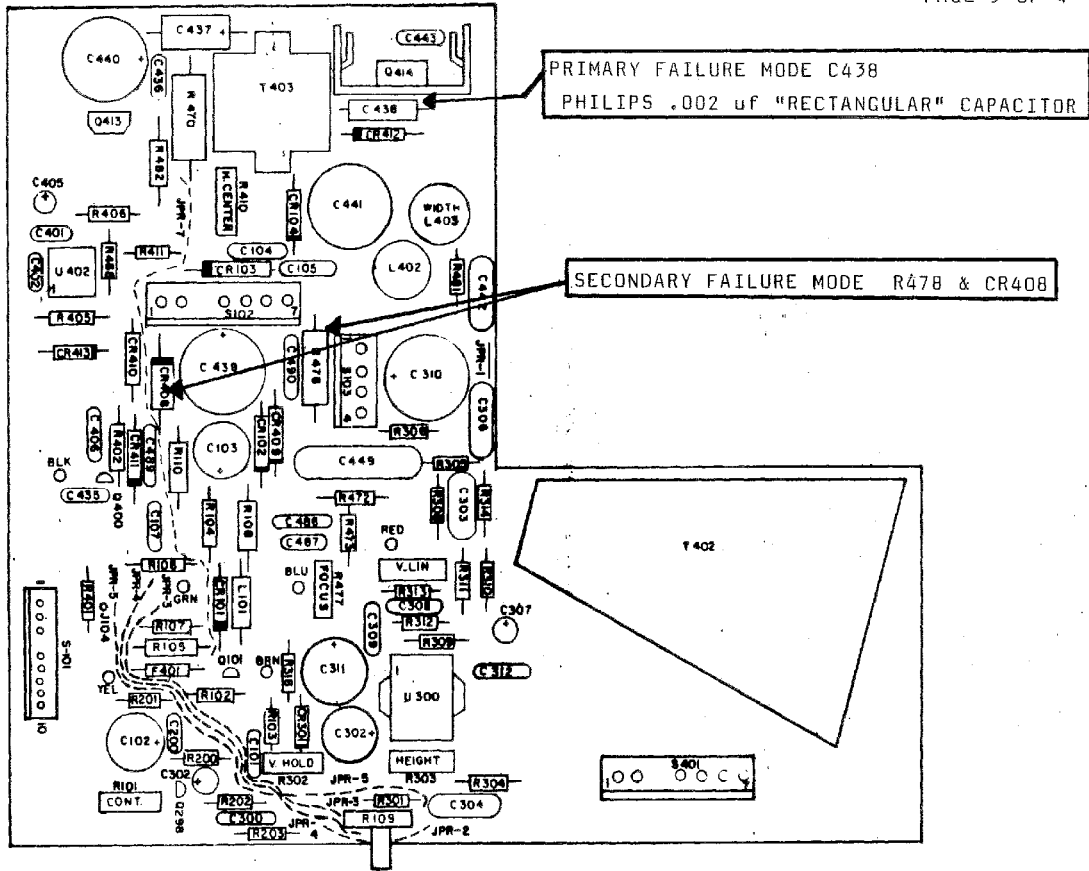
DM30-12B0-119-C31				
NORTH STAR				
DRAWN	DATE	APPVD	DATE	
D. DAUNCE	10/14/81	RGB	10-14-81	
ELSTON ELECTRONICS			RP	RGB

The primary failure mode is a failure of capacitor C438 on the Elston supplied video PCB. See attached assembly drawing (Figure 1) for parts location. NOTE: ONLY PCBs CONTAINING A YELLOW .022 Mf RECTANGULAR CAPACITOR MADE BY PHILIPS ARE PRONE TO THIS FAILURE. Boards containing an axial lead tubular .022 Mf capacitor are okay.

Once capacitor C438 fails, excessive current will flow through resistor R478 and diode CR408 causing failure of those components, discoloring and possible burning of the PCB material.

A monitor that has the problem in an advanced stage will exhibit a folding over of the characters in the first three inches (from the left side) of the screen. Three or four vertical lines on the left half of the screen or possibly a complete lack of video on the left side may also be apparent.

Failures can be detected early (prior to doing any permanent damage) by turning up the brightness to maximum on suspect ADVANTAGES. One should be able to detect a faint vertical line three to four inches from the left of the screen on affected machines. Since the failure, once started, degrades with time, the line will become brighter and characters on the left side of the screen will become distorted at late stages.

You may receive replacement capacitors free of charge by calling Barry Bearden at North Star. Additionally, North Star will issue a \$20.00 credit per ADVANTAGE to any Authorized Dealer, Distributor or OEM performing this modification. To receive this credit please indicate the serial number(s) of unit(s) being modified when you call. A credit memo will be issued upon verification of the serial number. Replacement of this capacitor by competent service personnel will not void the North Star warranty. NOTE: REPLACEMENT OF THE CAPACITOR SHOULD NOT EFFECT THE VIDEO ALIGNMENT OF THE ADVANTAGE.

Complete ADVANTAGES containing serial numbers listed on the attached may be returned to North Star Product Service for replacement of the defective capacitor.

Replacement Video PCBs will be supplied free of charge upon receipt of returned boards. If you choose this option please return the PCB as a warranty repair. North Star's Product Service Department will send a replacement board immediately upon receipt of the returned board. NOTE: REPLACEMENT OF THE VIDEO PCB WITHOUT ALSO REPLACING THE CRT REQUIRES REALIGNMENT OF THE VIDEO CIRCUITRY ON THE PCB. FOR THIS REASON OPTION THREE IS NOT RECOMMENDED.
